Data XRF analysis (Röntgenfluorescentiespectrometrisch onderzoek)

Object :	204 a (KN&V)	
Artist :	Anoniem	
Title and date :	Bokaal - dekselbokaal - radgravure	1675-1700
Conservator :	Mandy Slager - Restauratieatelier	
Analist :	Luc Megens - sr. Researcher RCE	
Date analysis :	22/03/2024 15:14:31

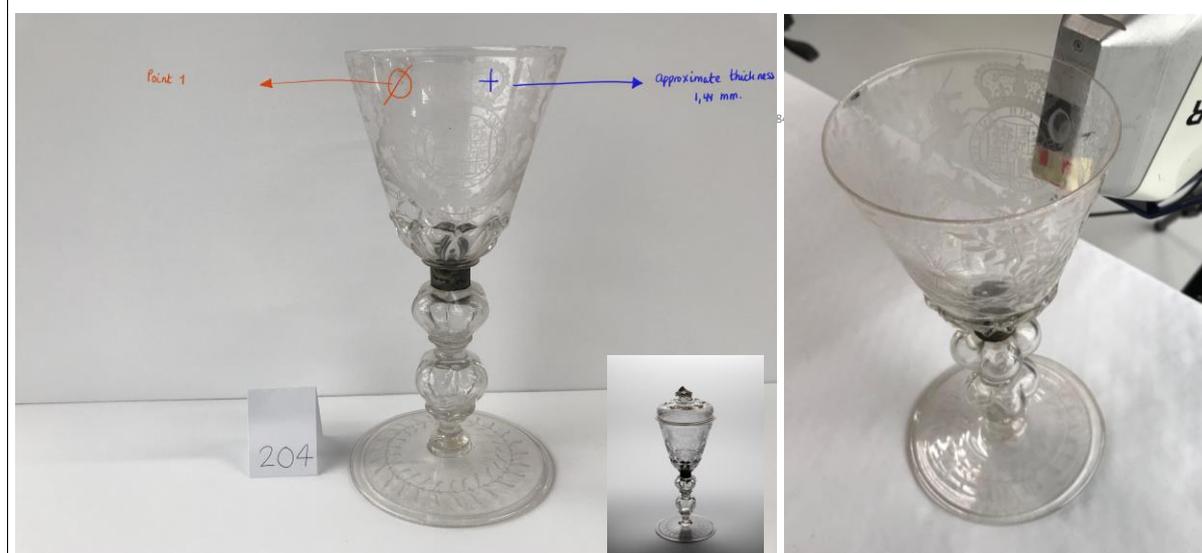
Location mapping of compositional analysis and measurement of approximate glass thickness

Practical limitations	Measurement at the point of analysis
App. thickness in mm.	1,44 (at location of measurement)

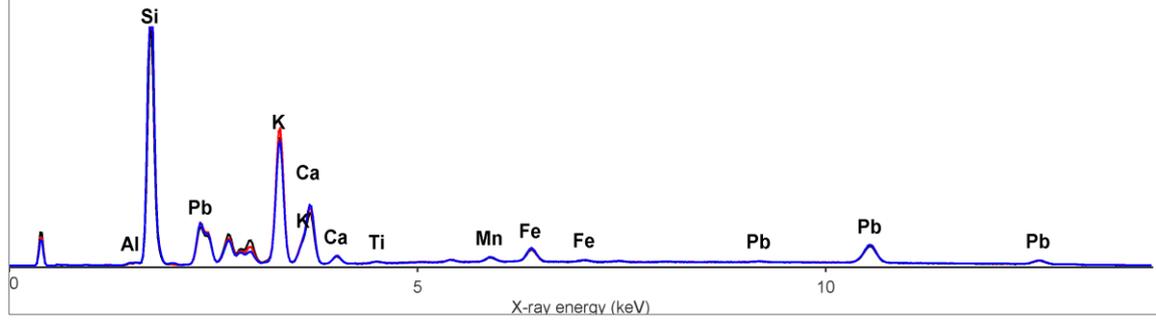
01401-Boymans glas_204_MudRock Maj15
 01402-Boymans glas_204_MudRock Maj15
 01403-Boymans glas_204_MudRock Maj15

file: 01401-Mudrock Air.pdz
 Tube Voltage: 15.0 kV current: 19.9 uA
 filter: none

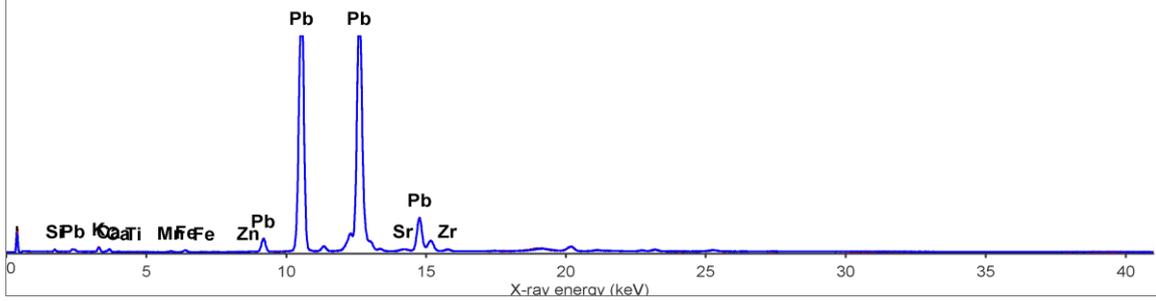
01401-Boymans glas_204_MudRock Trace50
 01402-Boymans glas_204_MudRock Trace50
 01403-Boymans glas_204_MudRock Trace50

file: 01401-Mudrock Air.pdz
 Tube Voltage: 50.0 kV current: 14.7 uA
 filter: Ti,25 / Al,300
