Data XRF analysis (Röntgenfluorescentiespectrometrisch onderzoek)

Object :	2495 (KN&V)	
Artist :	Tapio Wirkkala (design) - Murano (production)	
Title and date :	Vaas 503-1	1966-1967
Conservator :	Mandy Slager - Restauratieatelier	
Analist :	Luc Megens - sr. Researcher RCE	
Date analysis :	22-03-2024 17:50:05

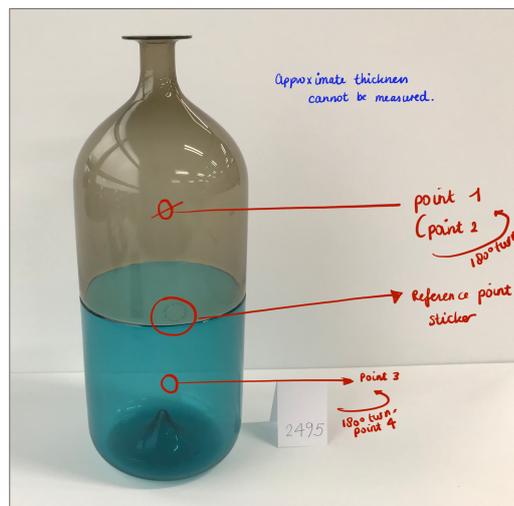
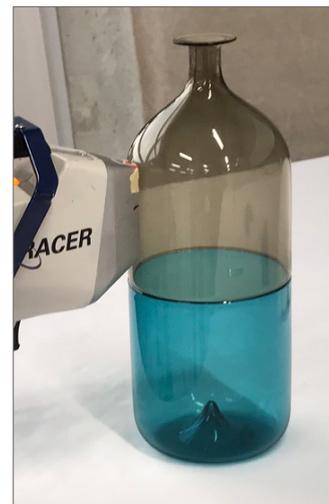
Location mapping of compositional analysis and measurement of approximate glass thickness

Practical limitations	None
App. thickness in mm.	Unknown (at point 1 and 2: brownish grey top part of glass)

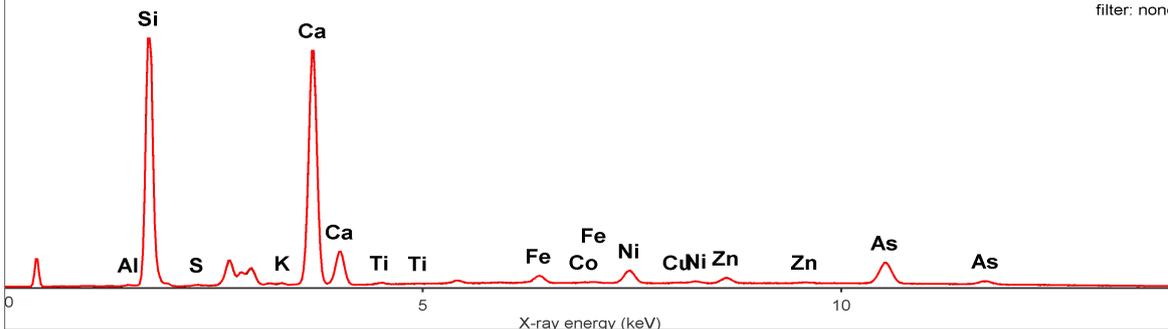
01430-Boymans glas_2495_MudRock Maj15
 01431-Boymans glas_2495_MudRock Maj15

file: 01431-Mudrock Air.pdz
 Tube Voltage: 15.0 kV current: 19.9 uA
 filter: none

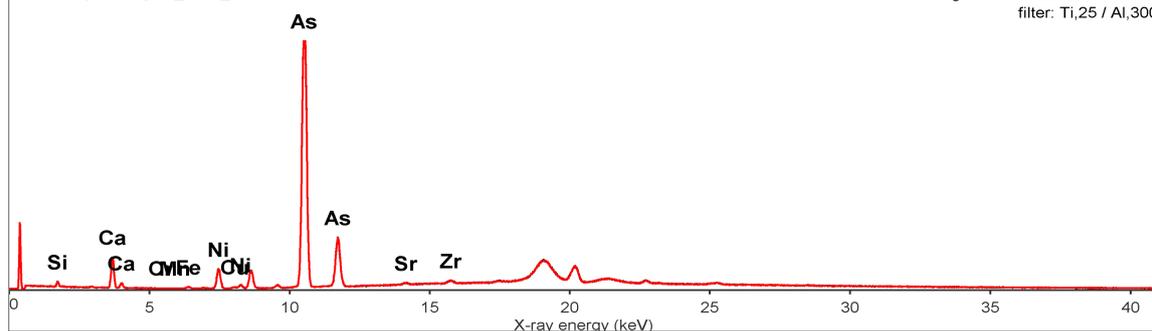
01430-Boymans glas_2495_MudRock Trace50
 01431-Boymans glas_2495_MudRock Trace50

file: 01431-Mudrock Air.pdz
 Tube Voltage: 50.0 kV current: 14.7 uA
 filter: Ti,25 / Al,300
