## Data XRF analysis (Röntgenfluorescentiespectrometrisch onderzoek)

| Object | 2495 (KN&V) | |
| Artist | Tapio Wirkkala (design) - Murano (production) | |
| Title and date | Vaas 503-1 | 1966-1967 |

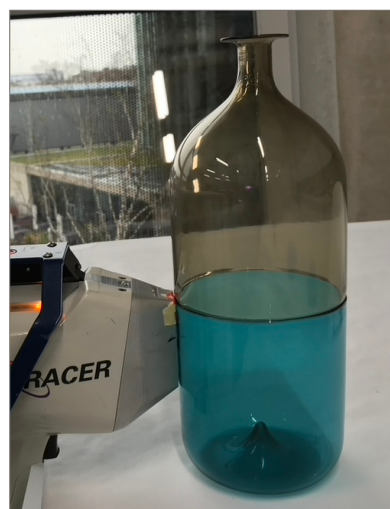
### Location mapping of compositional analysis and measurement of approximate glass thickness

| App. thickness in mm. | Unknown (at point 3 and 4: greenish/blue bottom part of glass) |
