## Data XRF analysis (Röntgenfluorescentiespectrometrisch onderzoek)

| Object : | <b>740 (KN&amp;V)</b> | |
| Title and date : | Vleugelglas - à la façon de Venise | 1600-1625 |

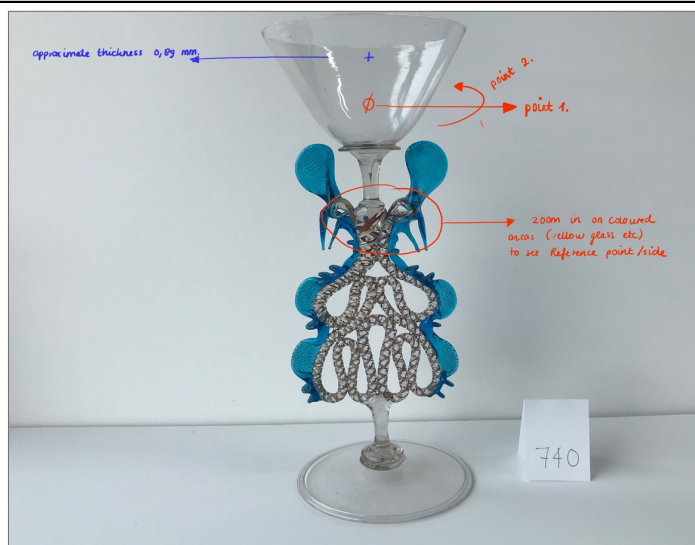
### Location mapping of compositional analysis and measurement of approximate glass thickness

| App. thickness in mm. | <b>0,89</b> (NOT at location of measurement: thickness near the rim of cuppa) |
