## Data XRF analysis (Röntgenfluorescentiespectrometrisch onderzoek)

| Object | 911 (KN&V) | |
| Title and date | Kelkglas - vrij-en vormgeblazen | 1600-1700 |

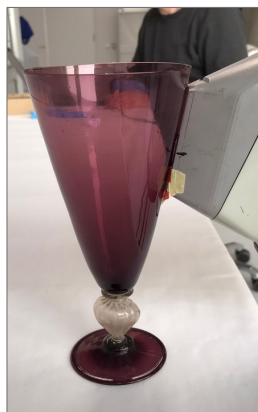
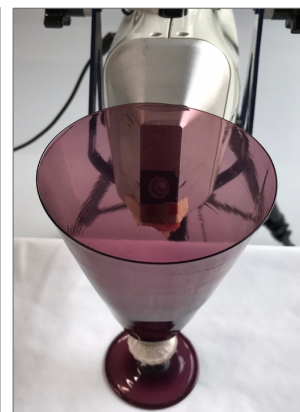
### Location mapping of compositional analysis and measurement of approximate glass thickness

| App. thickness in mm. | 0,68 (Not a location of every measurement) |

7. Attempts to measure the different areas (colourless streaks in glass as opposed to reddish areas) in the cuppa: was unfortunately not possible due to relatively large surface area of measurement.
