Data XRF analysis (Röntgenfluorescentiespectrometrisch onderzoek)

Object :	V 259 (KN&V) - transparant cilinder and exterior cuppa	
Artist :	Ettore Sottsass (execution Toso Vetri d'Arte)	
Title and date :	Sol - glass, freeblown, applique	1982
Conservator :	Mandy Slager - Restauratieatelier	
Analist :	Luc Megens - sr. Researcher RCE	
Date analysis :	21-03-2024 16:16:44

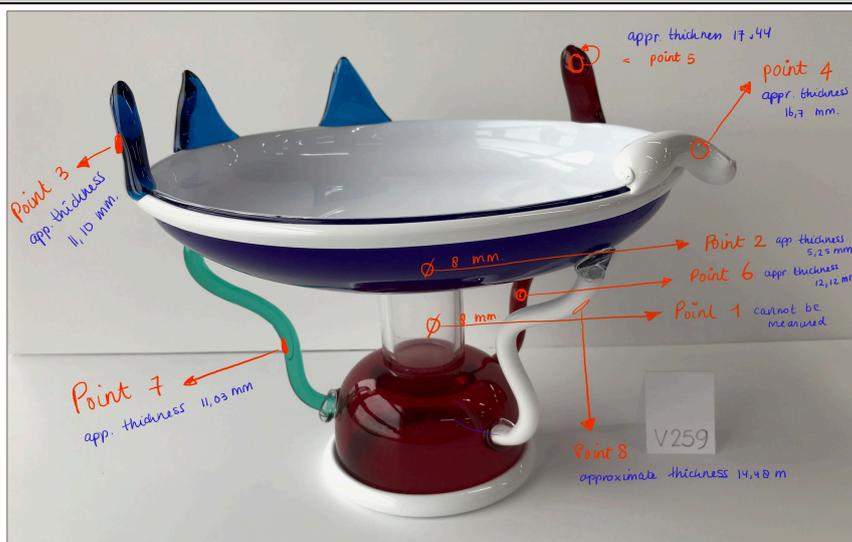
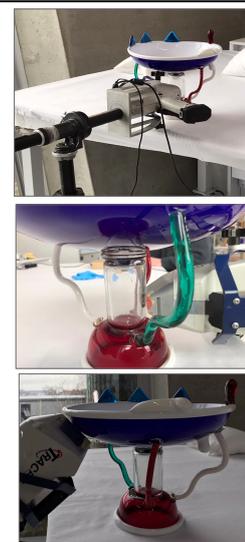
Location mapping of compositional analysis and measurement of approximate glass thickness

Practical limitations	None
App. thickness in mm.	5,25 (total of transparant layer including core of other colours as well (blue and white?) at location of measurement = point 1 and 2 - transparant and blue)
