Data XRF analysis (Röntgenfluorescentiespectrometrisch onderzoek)

Object :	V 63 d (KN&V)	
Artist :	Karel Petrus Cornelis de Bazel, Glasfabriek Leerdam	
Title and date :	Wijnglas, servies F, Annagroen loodglas	1921-1923
Conservator :	Mandy Slager - Restauratieatelier	
Analist :	Luc Megens - sr. Researcher RCE	
Date analysis :	22-03-2024 17:01:34

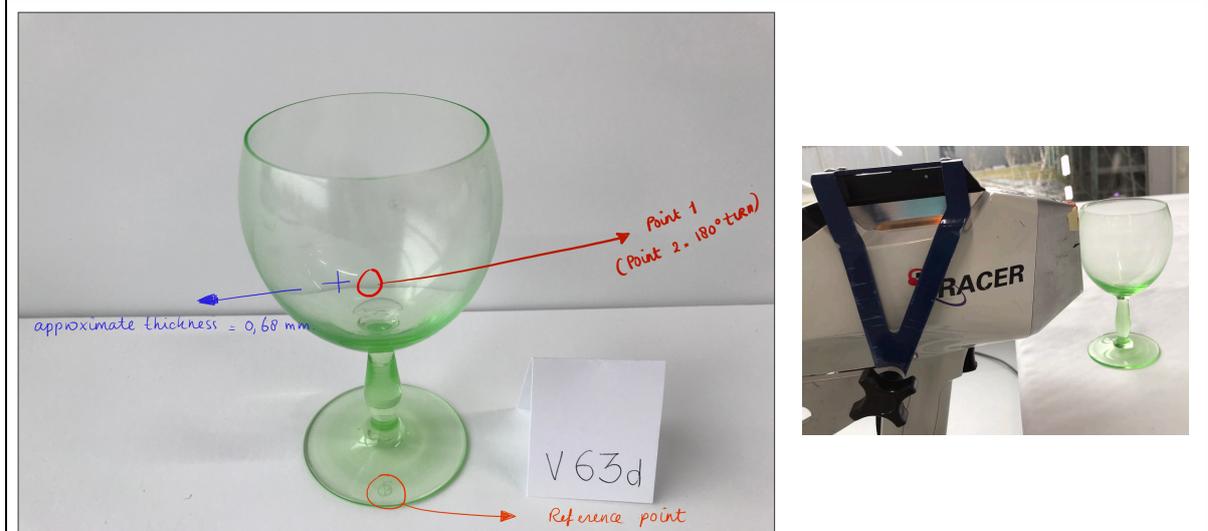
Location mapping of compositional analysis and measurement of approximate glass thickness

Practical limitations	None
App. thickness in mm.	0,68 (at point of measurement)
