Data XRF analysis (Röntgenfluorescentiespectrometrisch onderzoek)

Object :	V 86 d (KN&V)	
Artist :	Karel Petrus Cornelis de Bazel	
Title and date :	Servies F - Wijnglas	1921-1923
Conservator :	Mandy Slager - Restauratieatelier	
Analist :	Luc Megens - sr. Researcher RCE	
Date analysis :	22-03-2024 17:09:16

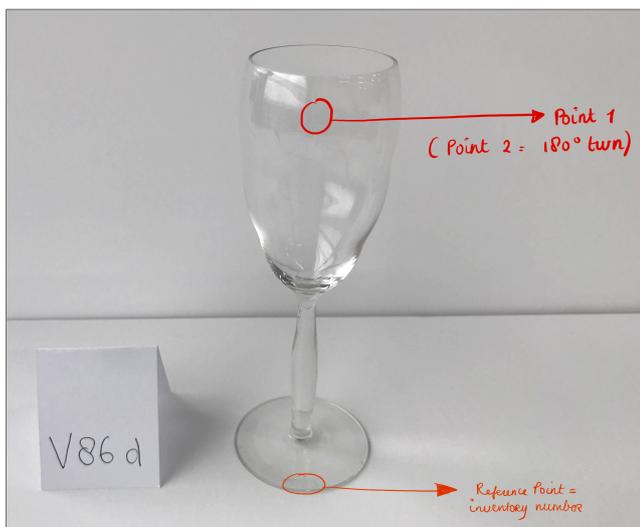
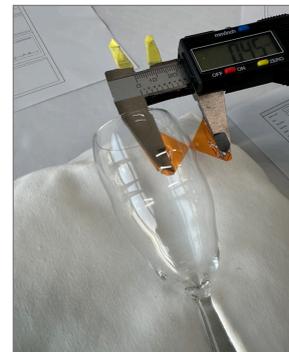
Location mapping of compositional analysis and measurement of approximate glass thickness

Practical limitations	Lead Glass (Crystal)
App. thickness in mm.	The reading in the image is not calibrated properly

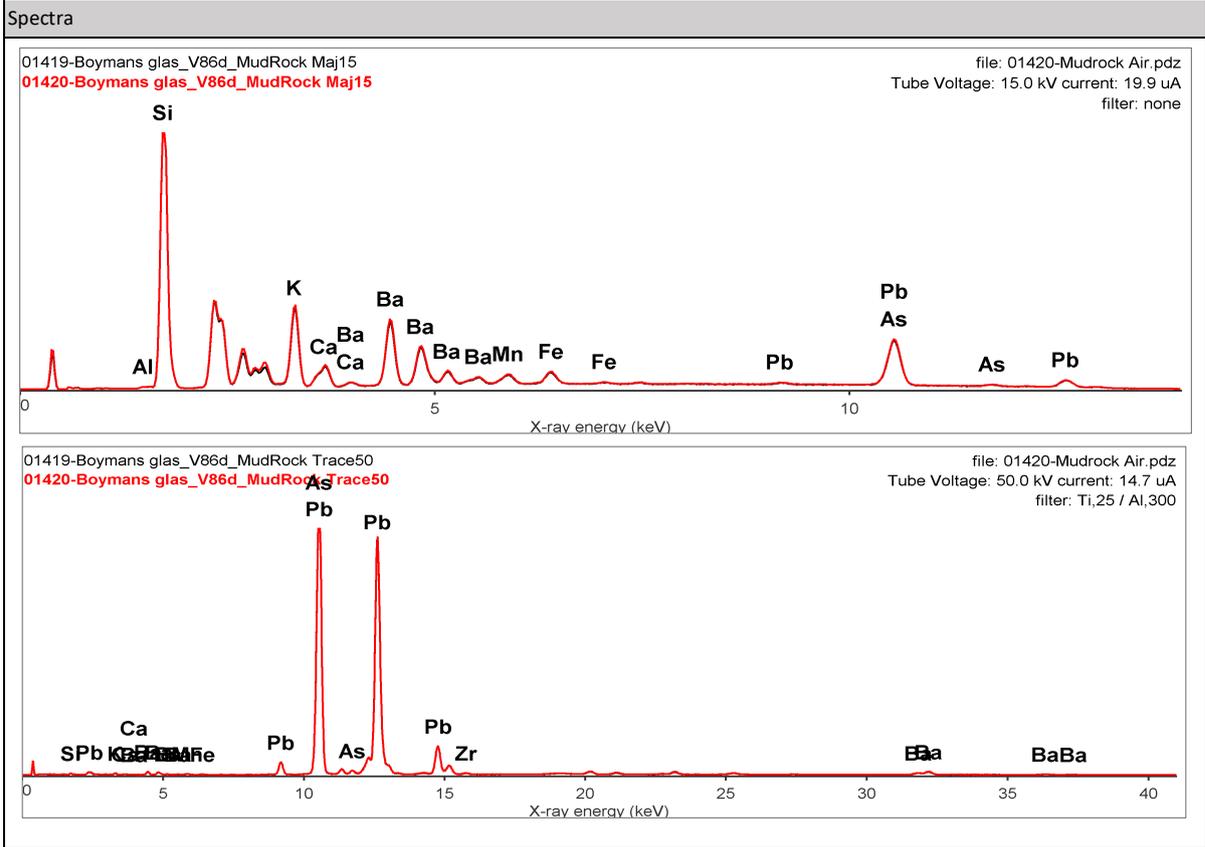
Results												
Limitations	Na2O can not be accurately quantified (underestimated). Sn and Sb are not quantified with the MudRock application. As isn't quantified properly in Pb glass. Quantitative results give an indication of composition, but not exact concentrations.											
Main elements in wt%	Na2O	MgO	Al2O3	SiO2	P2O5	SO3	K2O	CaO	ZnO	BaO	PbO	UO2
	3,65	0,28	< LOD	56,8	0,03	5,88	1,71	0,27	0,01	0,84	31,93	< LOD
Trace elements in ppm	Cl	Ti	V	Cr	Mn	Fe	Co	Ni	Cu	As	Rb/Sr	Zr/Mo
	854	4165	21	128	651	252	< LOD	84	69	68442	358/344	300/17
Type of glass I	Lead glass (Crystal)											
Type of glass II	Other 1

In absolute and relative comparison a larger spreading of the K₂O and PbO measures can be detected. This is mostly due to the fact that the energy the fluorescent radiation of K emits is lower than of Pb. De subsequent percentage calculations derive from this. With greater distance of the detector to the surface the radiation of K is absorbed much stronger by the air than is the case with Pb.
