Data XRF analysis (Röntgenfluorescentiespectrometrisch onderzoek)

Object :	**V 2466 (KN&V)**
Artist :	Ettore Sottsass (design) - Vistosi (production)
Title and date :	Orsete - applications | 1972
Conservator :	Mandy Slager - Restauratieatelier
Analist :	Luc Megens - sr. Researcher RCE
Date analysis :	22-03-2024 16:19:21

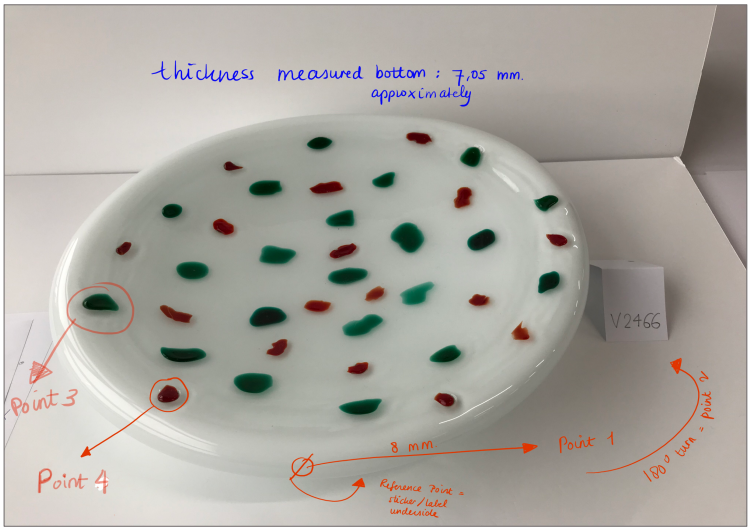
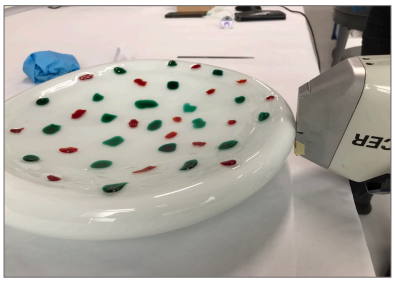
Location mapping of compositional analysis and measurement of approximate glass thickness

Practical limitations	None
App. thickness in mm.	**7,05** (not at location of measurement, but thickness taken at the bottom: likely similar) - point 1/2 - white glass

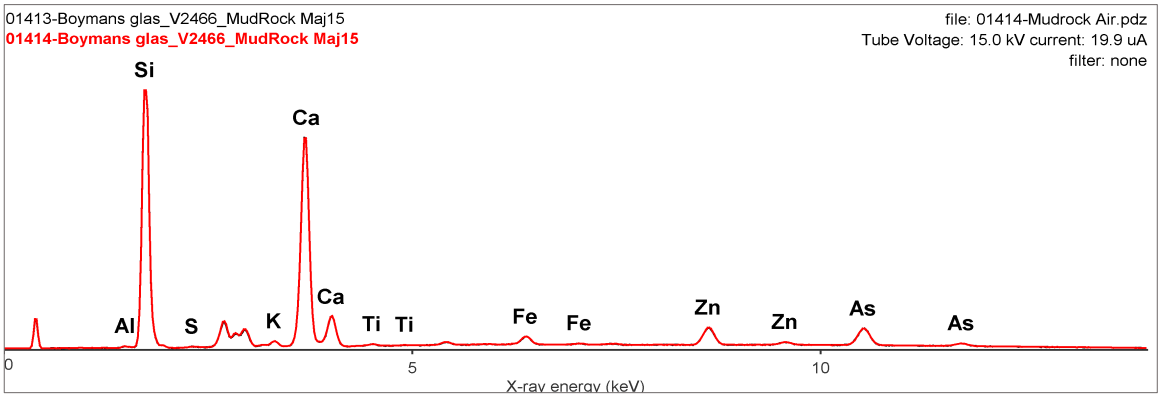
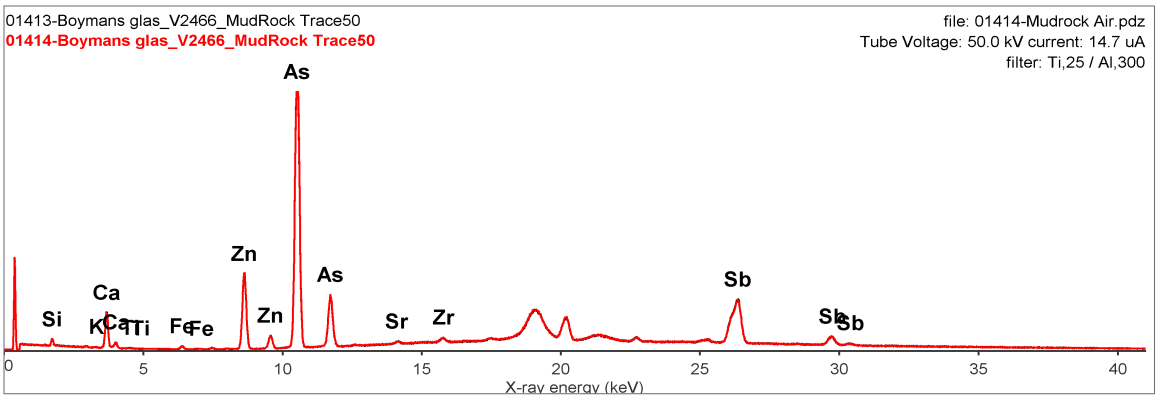
Spectra

In absolute and relative comparison a larger spreading of the K2O and PbO measures can be detected. This is mostly due to the fact that the energy the fluorescent radiation of K emits is lower than of Pb. De subsequent percentage calculations derive from this. With greater distance of the detector to the surface the radiation of K is abosrbed much stronger by the air than is the case with Pb.
